**Regulatory Audit
of
Preliminary Assessment Report
By
Meth Lab Cleanup, LLC
at an
Identified Illegal Drug Laboratory**

**836 Prospect Lake Drive
Colorado Springs, CO**

May 18, 2015

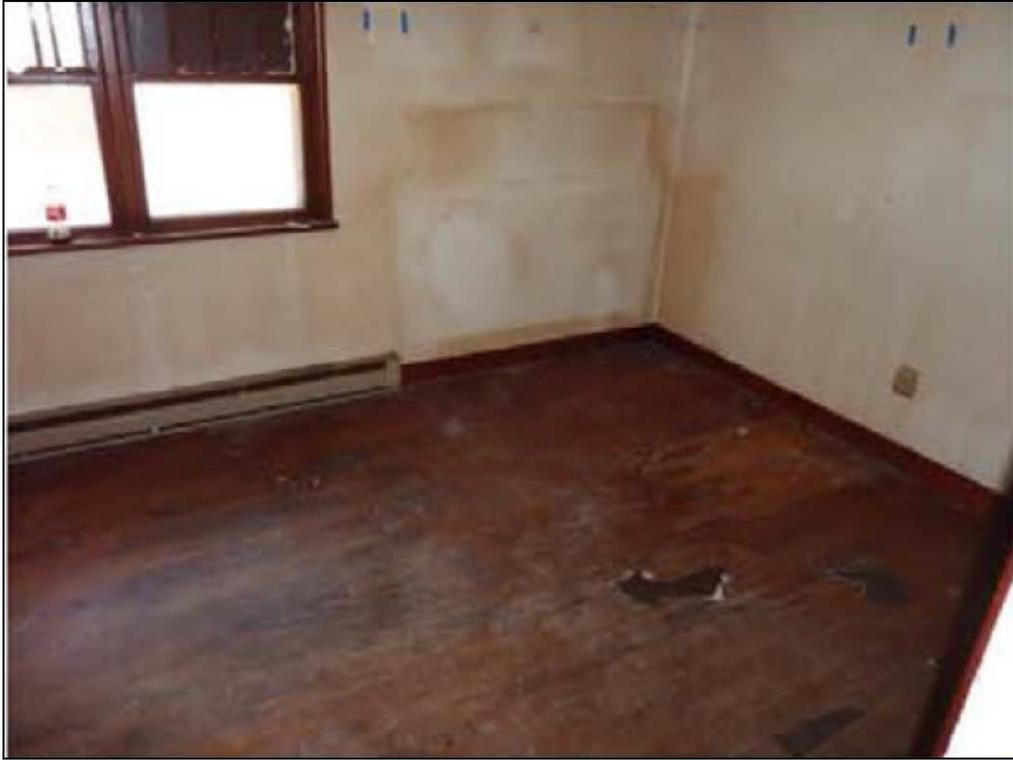
The consultant failed to identify the staining in this photograph:

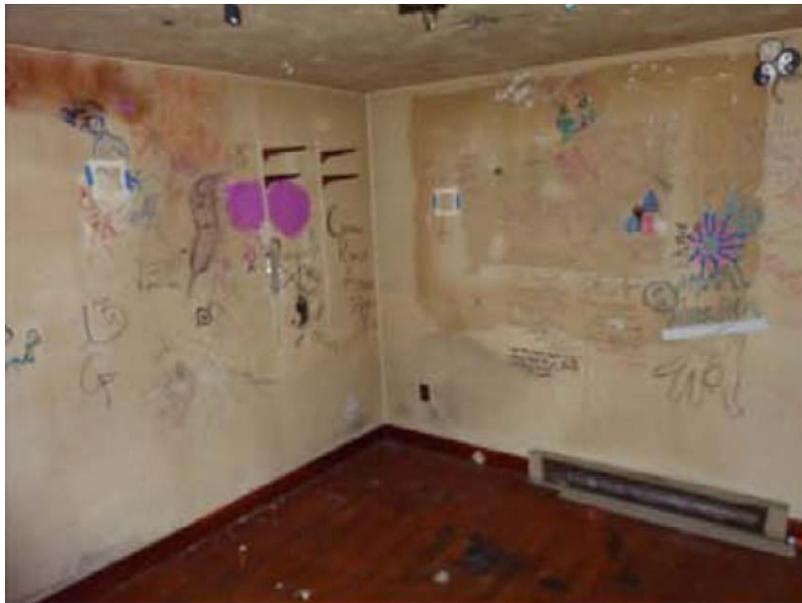
The consultant failed to identify the staining in this photograph:

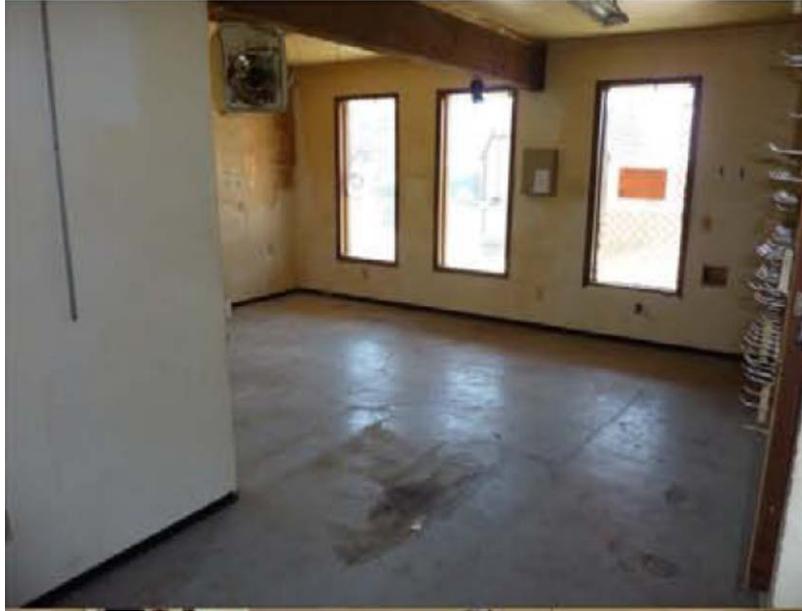
The consultant failed to identify the staining in this photograph:

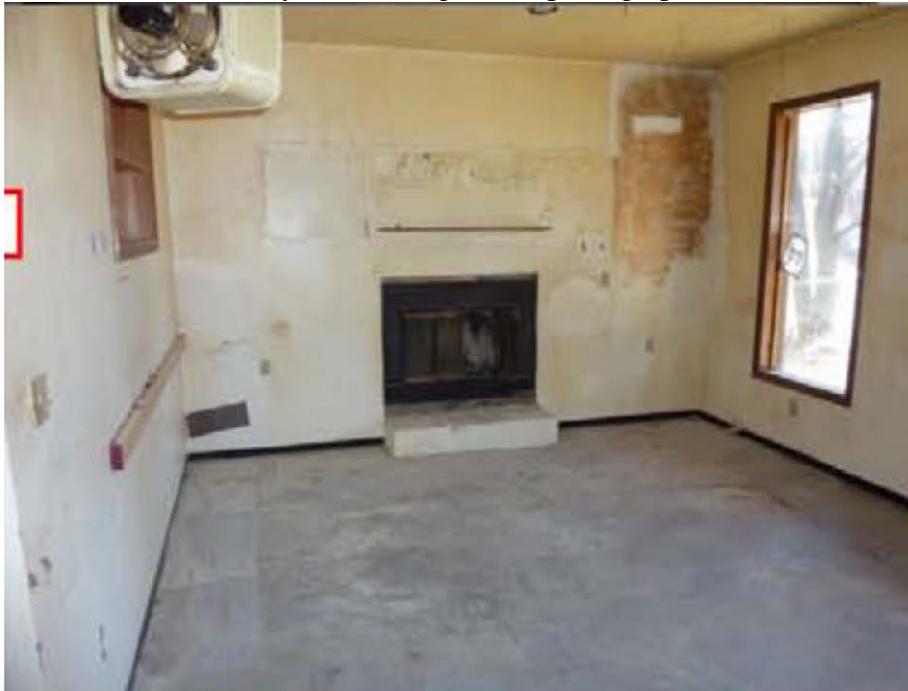
The consultant failed to identify the staining in this photograph:

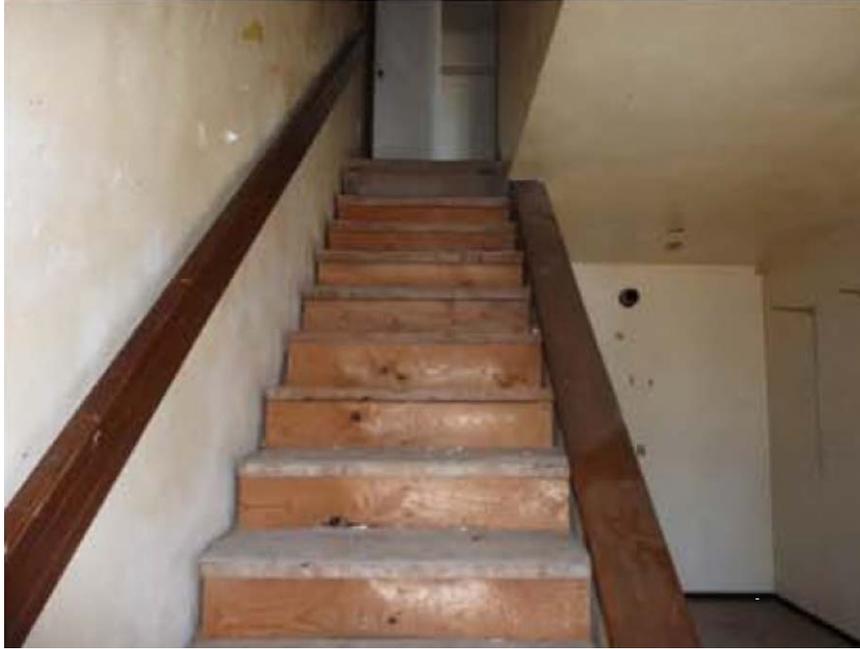
The consultant failed to identify the staining in this photograph:

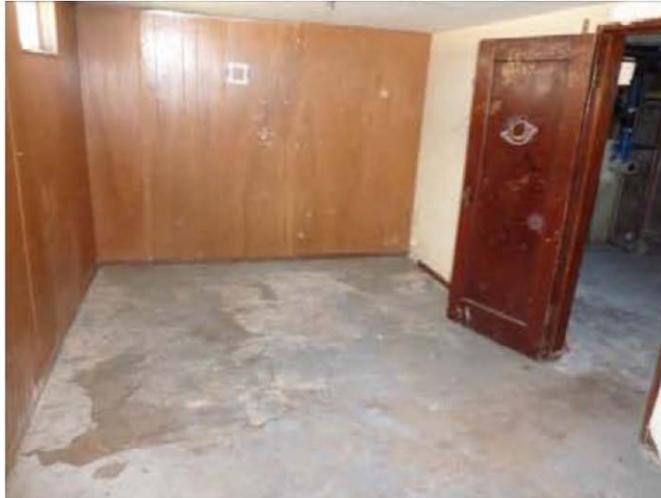
The consultant failed to identify the staining in this photograph:

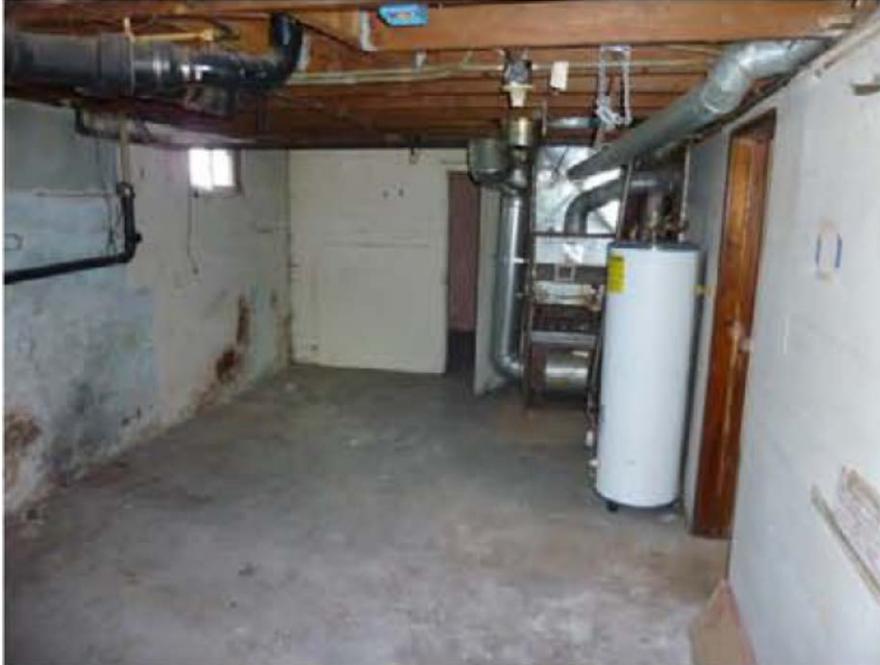
The consultant failed to identify the staining in this photograph:

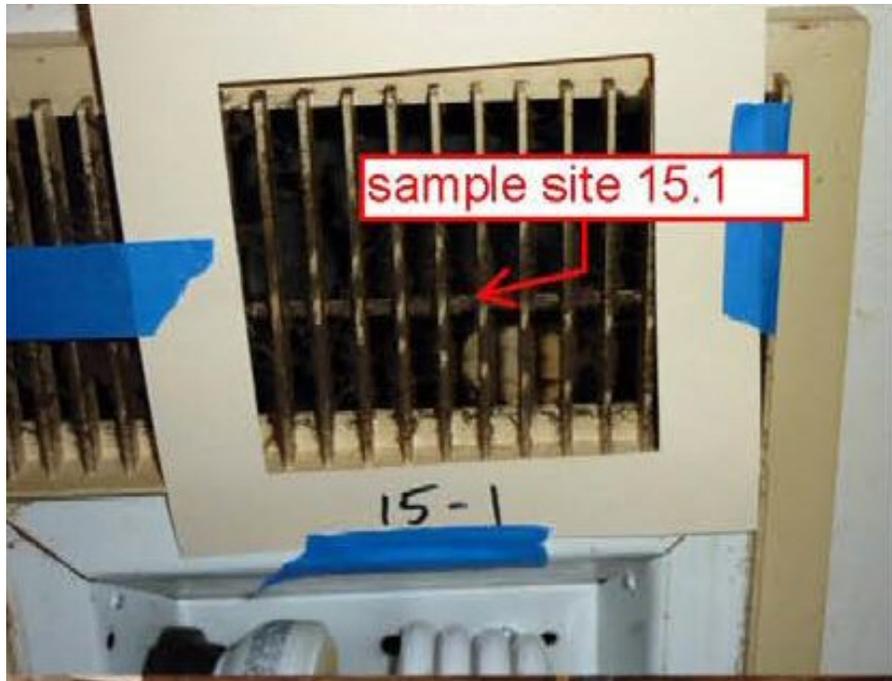
Photograph 1
MLCC Photograph Sample 15

For this property, MLCC failed to comply with the sampling protocols and also exhibited a lack of knowledge in sampling procedures. In their report, MLCC indicates they knowingly provided false information to the analyzing laboratory, and to the client.

In the photograph below, MLCC depicts a sampling location delineated with a 10 cm X 10 cm template.

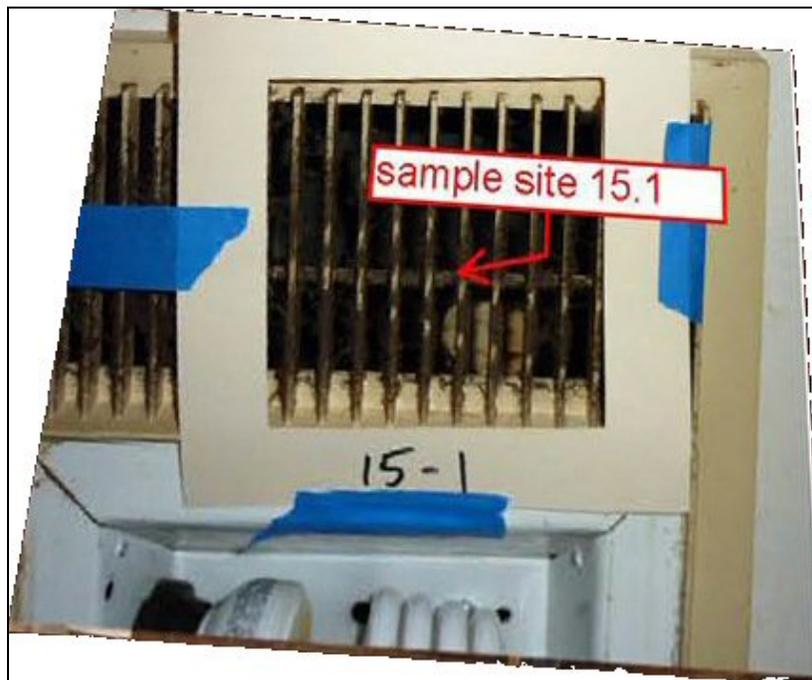
Photograph 2
Distortion Corrected Sample Location

Using distortion correcting software, we can correct the perspective of the photograph and then, using the template as the scale, calculate the actual area sampled. Thus the distortion corrected photograph for the above sample is depicted below:
