**Regulatory Audit
of
Preliminary Assessment Report
By
Meth Lab Cleanup, LLC
at an
Identified Illegal Drug Laboratory**

**836 Prospect Lake Drive
Colorado Springs, CO**

May 18, 2015

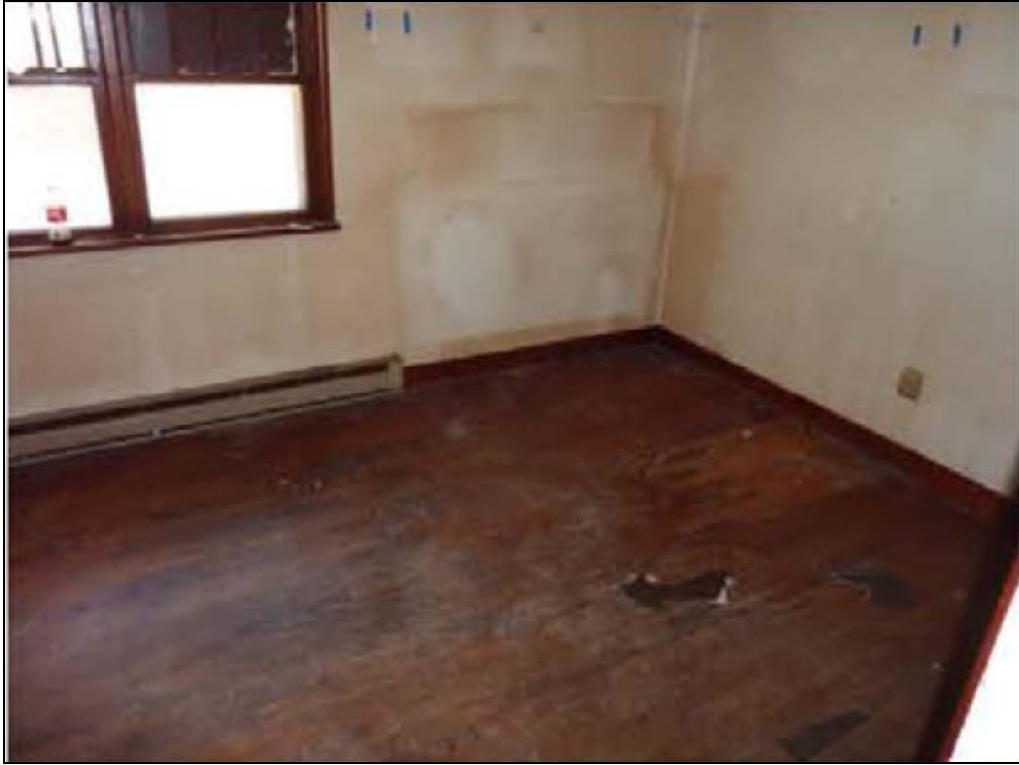
The consultant failed to identify the staining in this photograph:

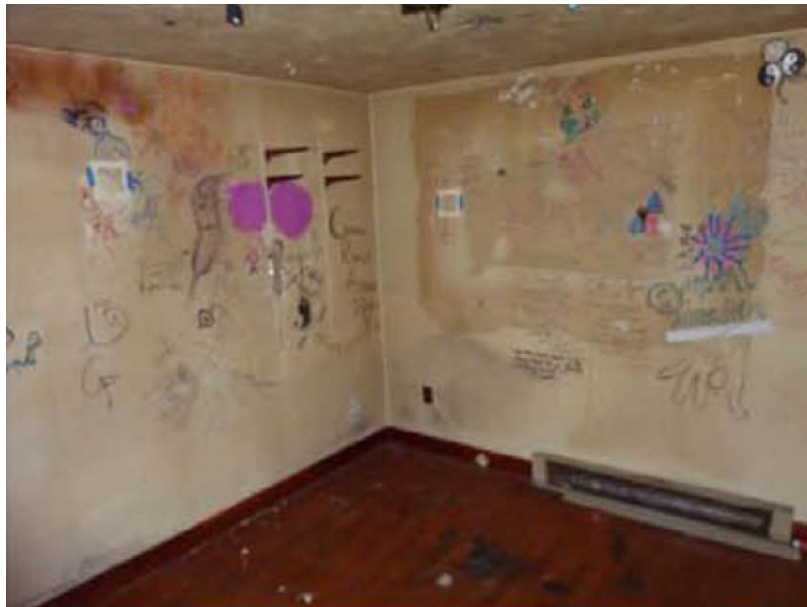
The consultant failed to identify the staining in this photograph:

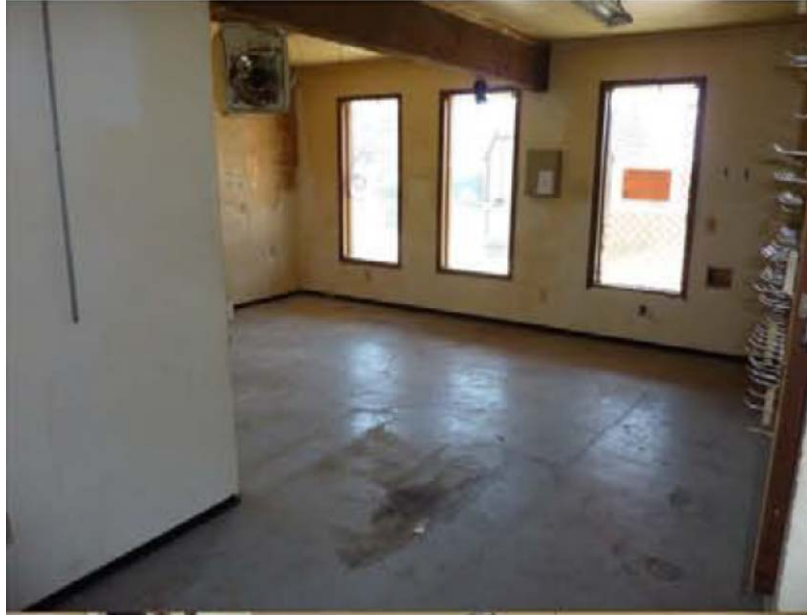
The consultant failed to identify the staining in this photograph:

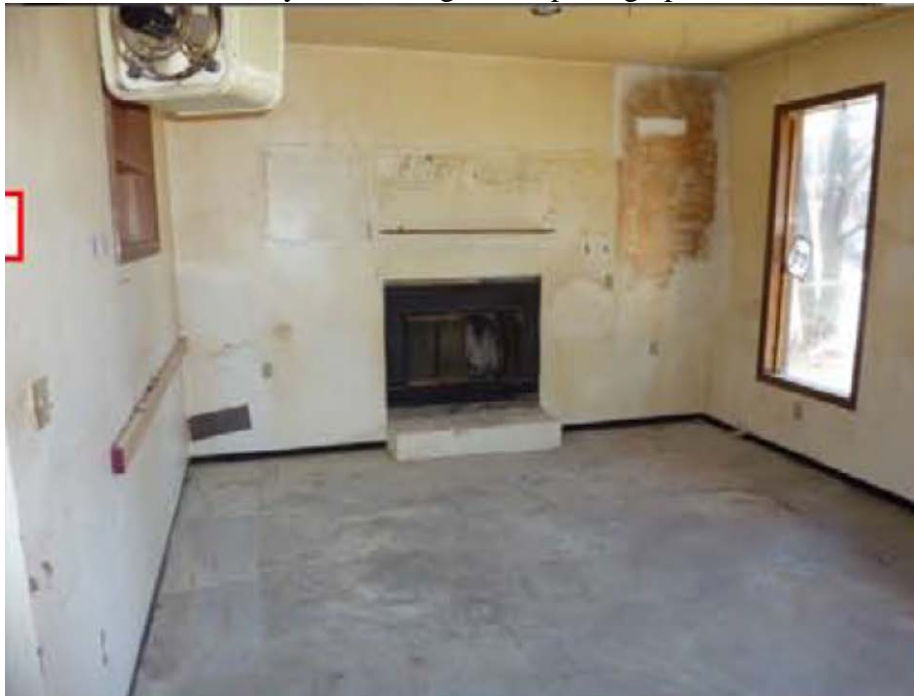
The consultant failed to identify the staining in this photograph:

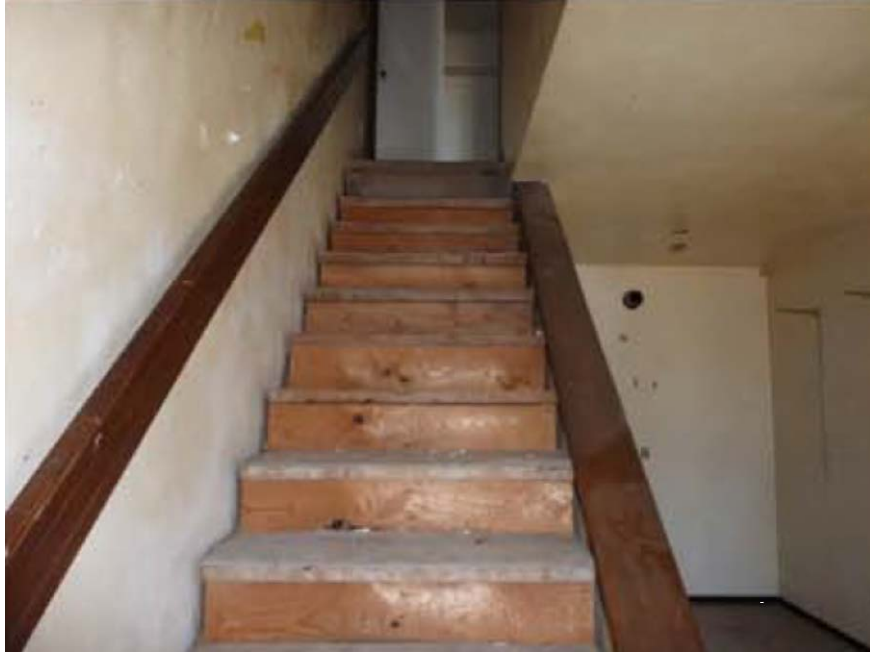
The consultant failed to identify the staining in this photograph:

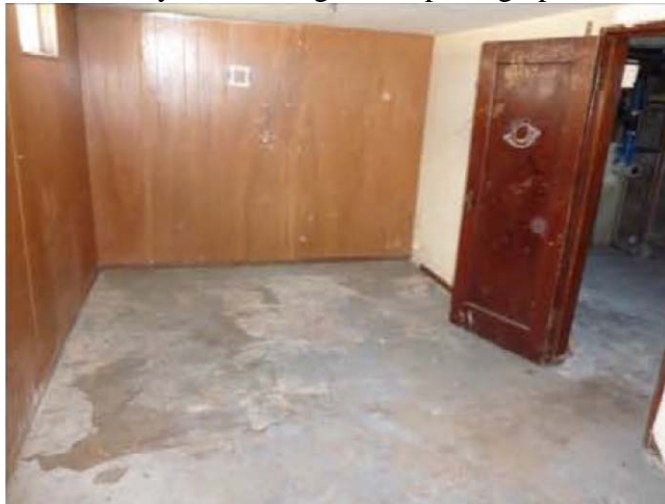
The consultant failed to identify the staining in this photograph:

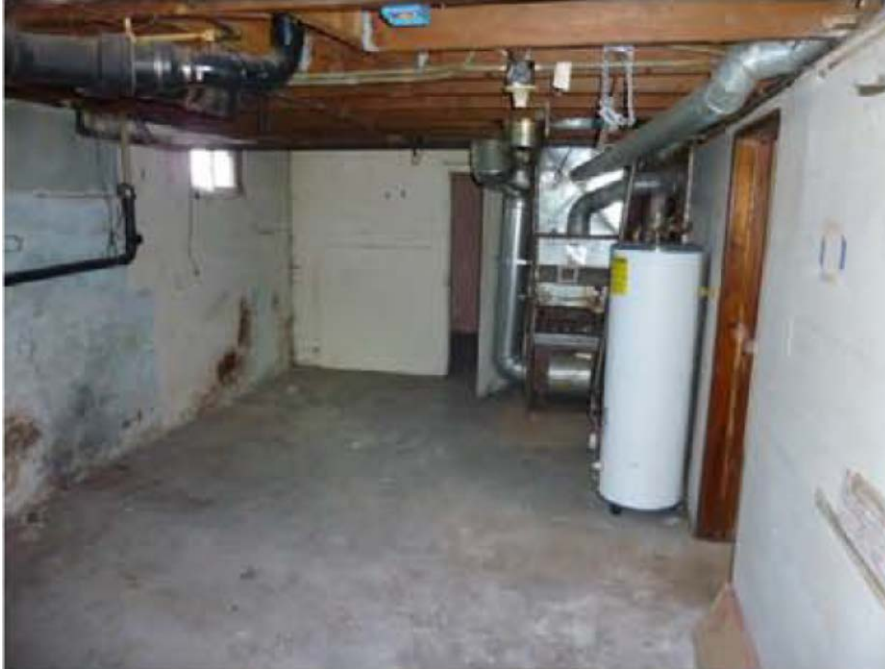
The consultant failed to identify the staining in this photograph:

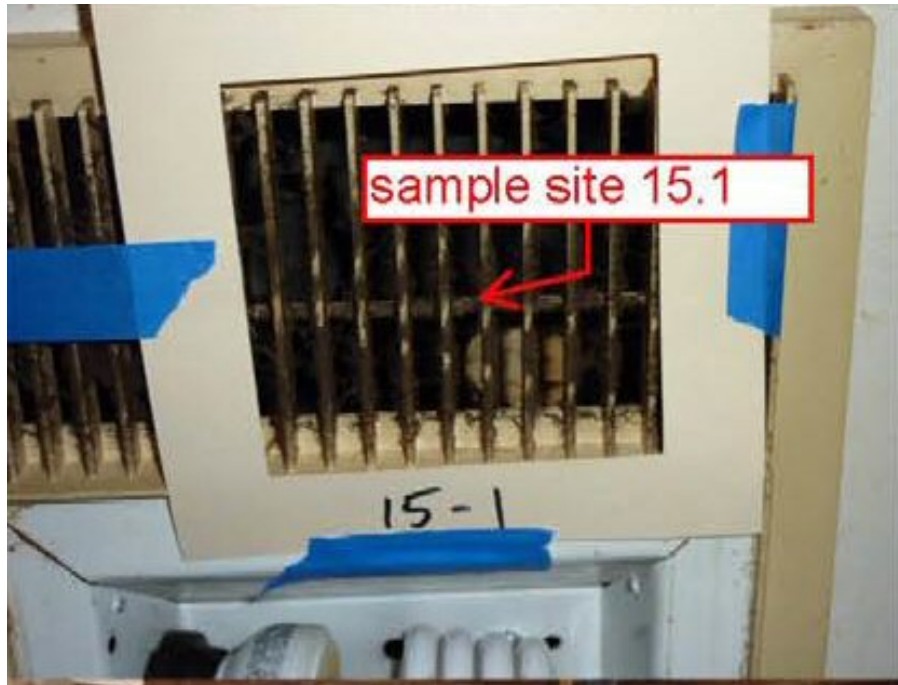
Photograph 1
MLCC Photograph Sample 15

In the photograph below, MLCC depicts a sampling location delineated with a 10 cm X 10 cm template.

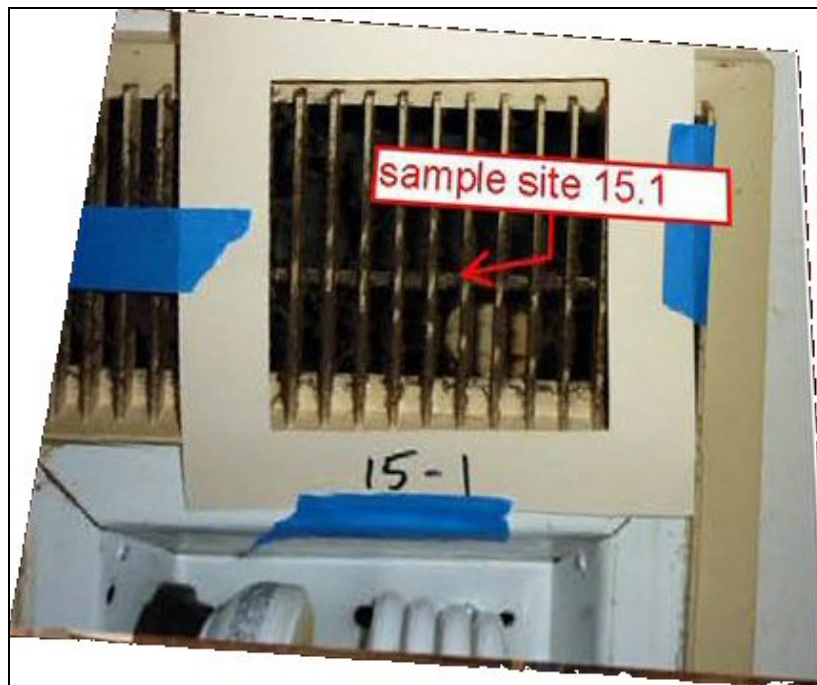
Photograph 2
Distortion Corrected Sample Location

Using distortion correcting software, we can correct the perspective of the photograph and then, using the template as the scale, calculate the actual area sampled. Thus the distortion corrected photograph for the above sample is depicted below:
