**Preliminary Assessment
of an
Identified Illegal Drug Laboratory
at
2927 Main Street
Colorado Springs, CO, 80907-6013**

Prepared for:
Environmental Claims Office
Farmers Insurance
31051 Agoura Rd
Westlake Village, CA 91361
(Claim Number 1014677654-1-1)

October 13, 2009

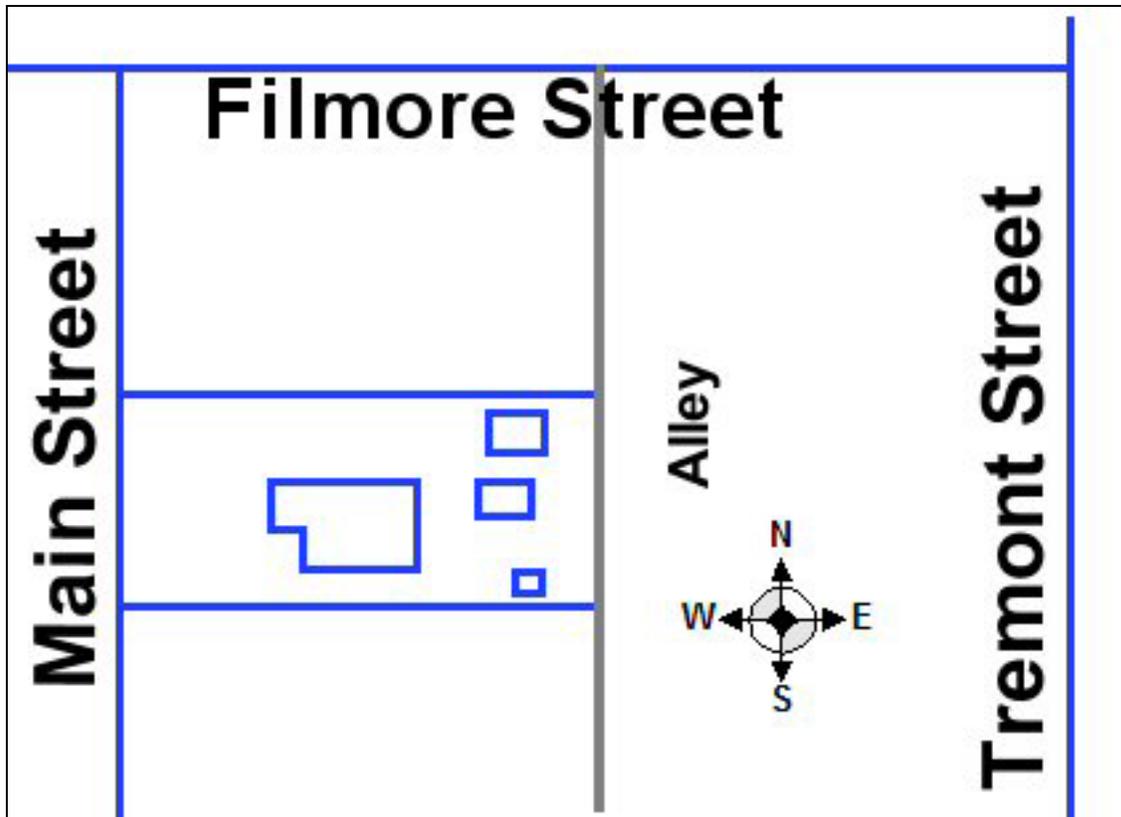
**Figure 1
General Site Layout**

- 1) Structure 1: Primary Residential Structure
- 2) Structure 2: Exterior South Metal Shed
- 3) Structure 3: Exterior Central Garage
- 4) Structure 4: Exterior North Garage

A general layout of the structures is depicted in the drawing below. Figure 1, below is not to scale, however, the drawing is proportional.

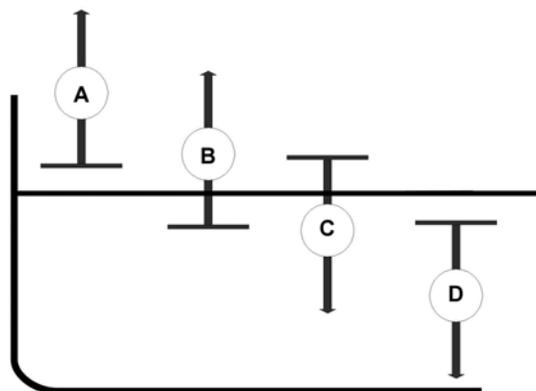
Figure 3

Compliance, and the decision to remediate or not remediate, is based not only on the reported value, but also on the statistical uncertainty of the results. So, in the drawing below, where the reported value (A) and the LCL are greater than the decision threshold (the horizontal line), we are *confident* the reported value indicates noncompliance. Where the reported value (D) and the UCL are less than the decision threshold, we are *confident* the reported value indicates compliance.

However, there is an ambiguous zone of reported values, such as (B), where although the reported value is greater than the decision threshold, there is a probability the true value is less than the decision threshold. Similarly, where the reported value is less than the decision threshold, there is a probability the true value is greater than the decision threshold (C).

Uncertainty in Reported Values

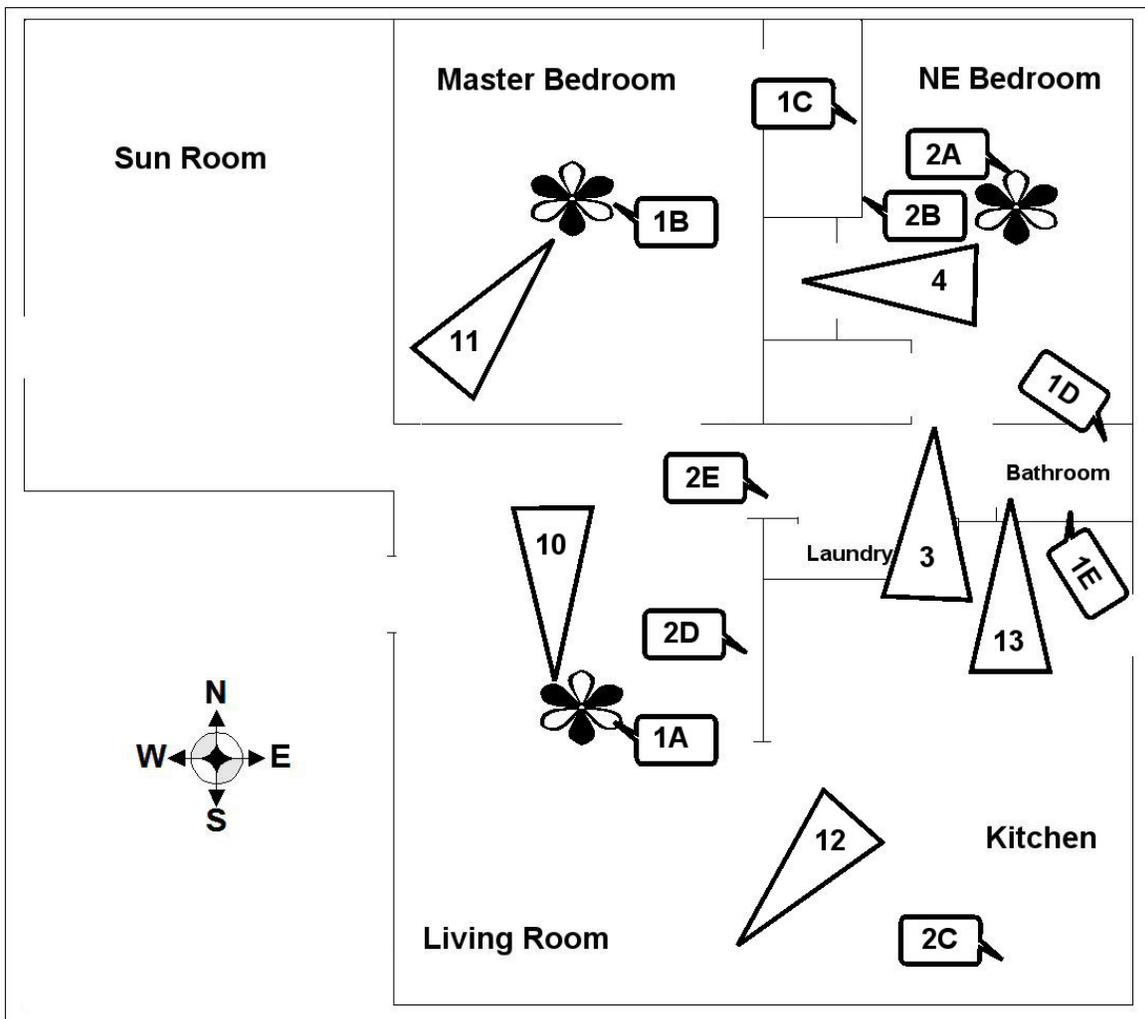
Figure 4
Sample Locations Main Floor- Not to Scale

The samples indicate widespread contamination in the primary structure, and compliant conditions in the attic, and each of the exterior buildings.

In the figures that follow, the sample locations have been presented. The drawings are stylized and not to scale. In the diagrams, the sample locations indicated by triangles were collected on September 22, 2009; those indicated by call-out boxes were collected on August 20, 2009.

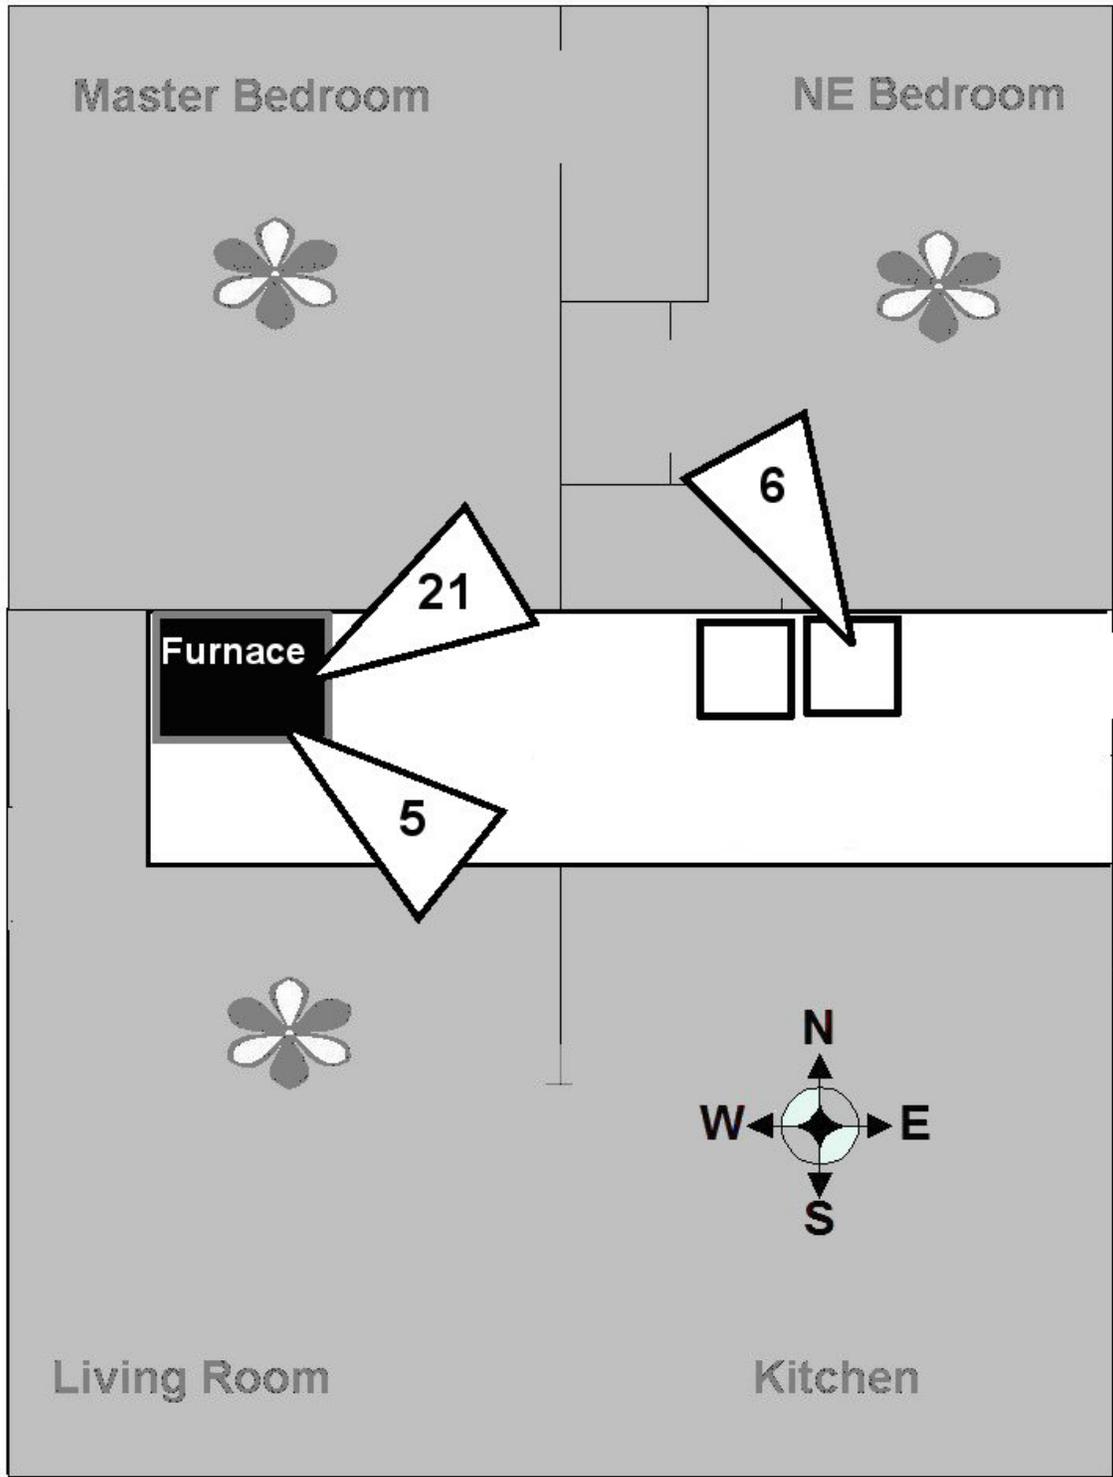
Figure 6
Sample Locations Crawlspace Level- Not to Scale

Finally, Sample AM092209-21 is a sample from the furnace filter in the crawlspace. The sample was collected to determine the need to remediate the furnace system. The sample was under sampled by 50% and, in accordance with standard practice, the value shown is a “corrected” value (the result has been doubled to account for the “missing” material).

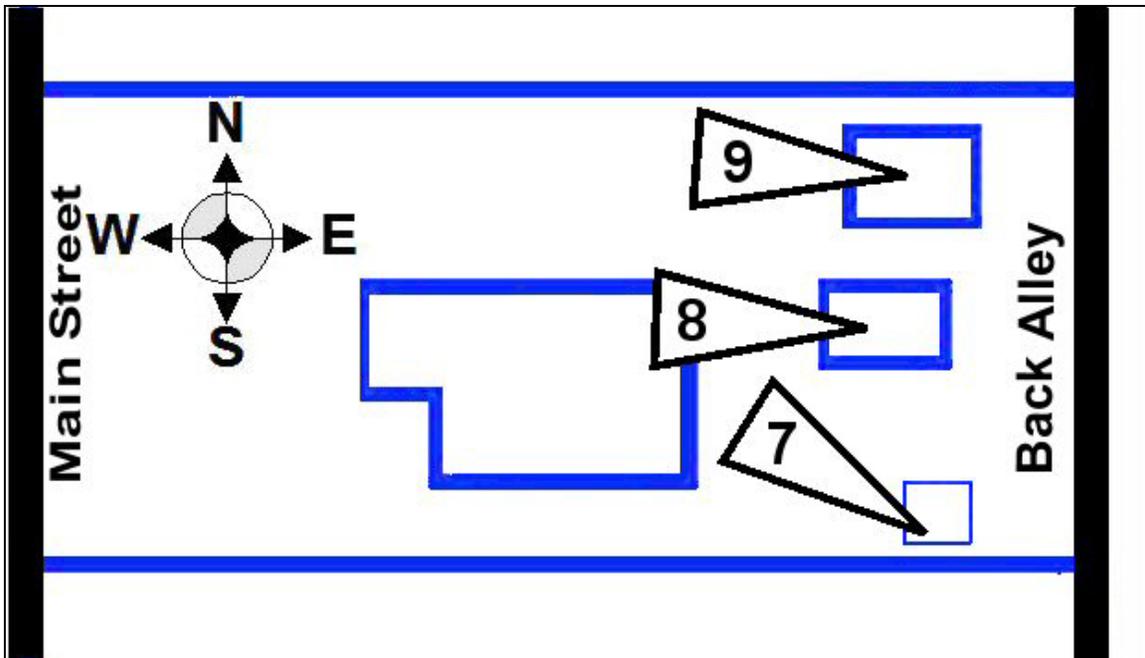
Figure 7
Sample Locations Exterior structures - Not to Scale

The south shed is a common kit-built metal shed. The previous occupants had access to this area. The shed contained considerable boxes and debris. We did not dig through the various boxes of trash and other items, but rather inspected the materials as we found them. We did not observe any visual indicators consistent with controlled substances activities. A single discreet sample collected from this area indicated that the space is compliant and may be excluded from the remediation process.

This area contained a large number of items and storage boxes. We did not disturb any of the boxes or items, but reviewed the contents as we found them. We did not observe any visual indicators consistent with controlled substances activities in this area. A single discreet sample collected from this area indicated that the space is compliant and may be excluded from the remediation process.
