**Preliminary Assessment
of an
Identified Illegal Drug Laboratory
at:**

**198 Blueberry Trail
Bailey, Colorado 80421**

June 25, 2011

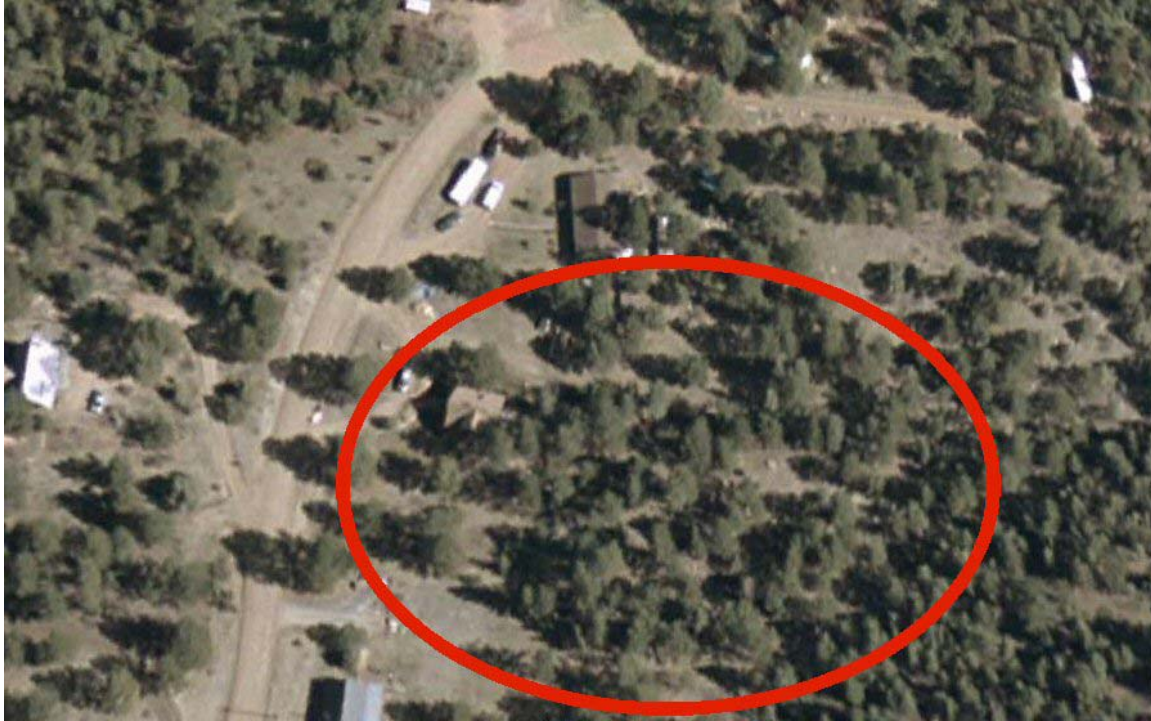
**Figure 1
General Site Layout⁸**

A general aerial layout of the residential setting is depicted in the aerial photograph below. A plat map was not readily available, and therefore the property line is not depicted but, rather, a general site location is indicated by the red ellipse.

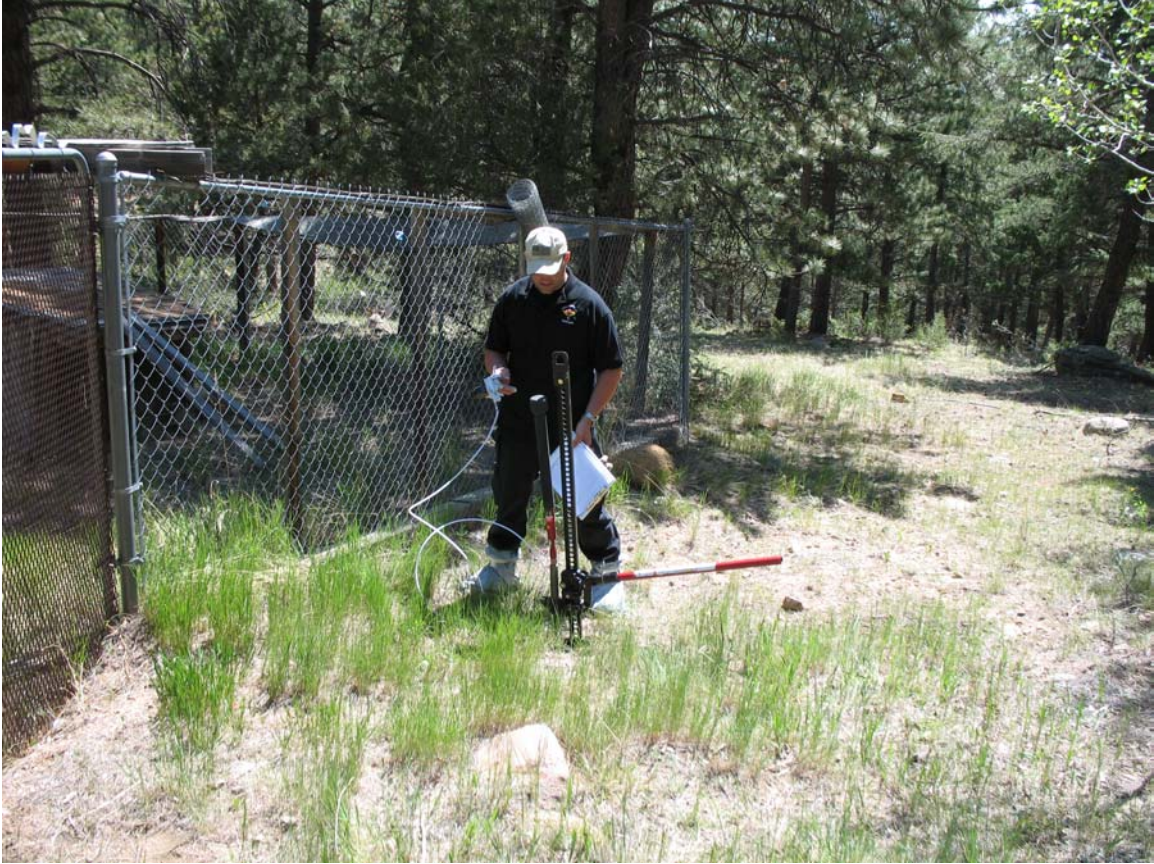
Photograph 1
Direct Push Soil Gas Sampling

To assess the soils around the septic tanks and the leach field, FACTs employed direct push soil sampling techniques, wherein we drove an hollow gas sampling tip to a desired depth in the soils. The tip is attached to a length of Teflon® tubing, and using an high vacuum hand pump, soil gases are extracted into a Tedlar® gas sampling bag (See Photograph 1, below). The accompanying DVD also has a video clip of the soil gas sampling procedure. Gases from the Tedlar bag are then introduced into suitable instruments for direct reading qualitative analysis (in this case, we measured broad range hydrocarbons and acid gases).

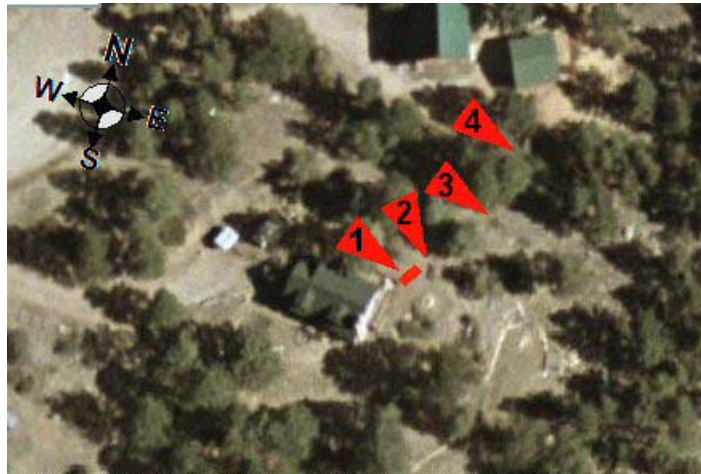
Figure 2
Soil Gas Probe Sampling Locations

The diagram that follows provides the approximate locations for each of the soil gas probe sampling locations. The large red outlined square identifies the location of the septic tank; the red triangles are the locations where the soil gas was sampled.

All soil gas samples were collected exclusively down gradient from the septic system. One sample (Number 4) was collected over the property line at the residence to the north. The location in the photograph are approximations, the actual locations are given on Form ML 6 included with this discussion.

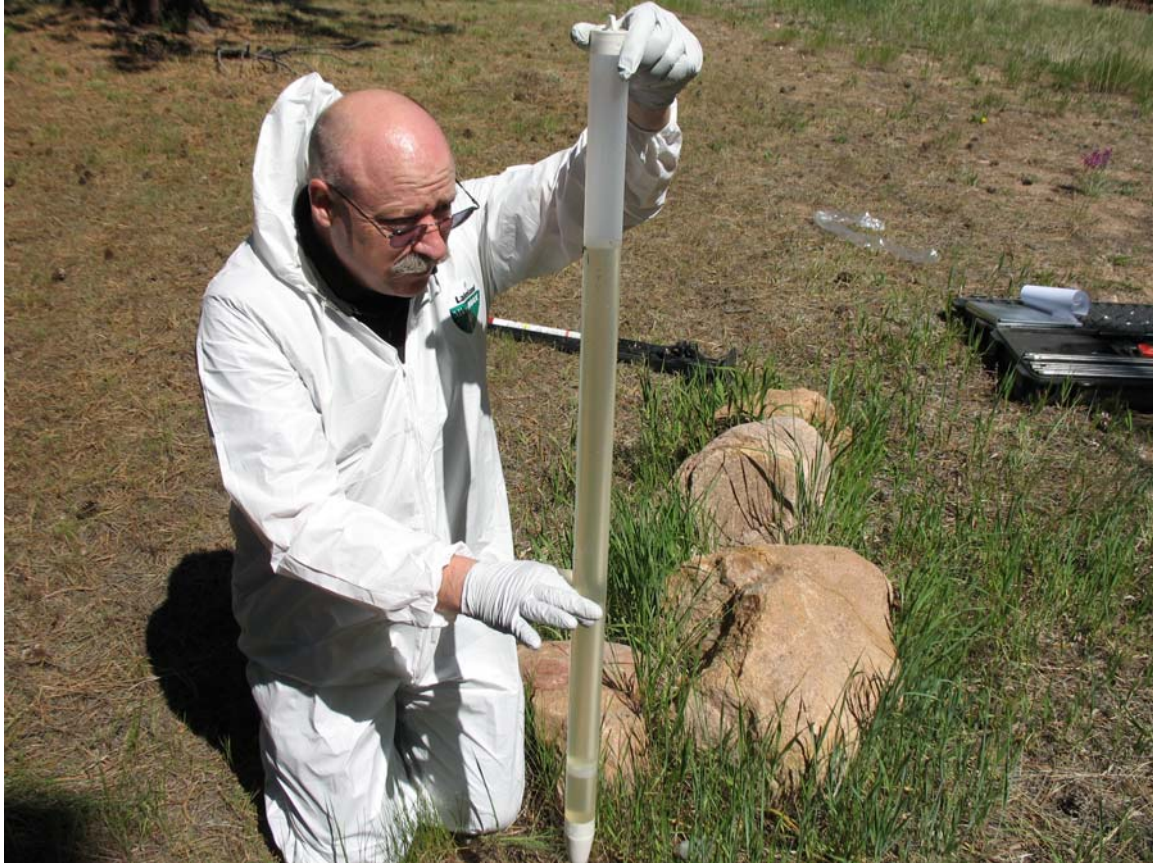
Photograph 2
Coliwasa Stratified Septic Tank Contents

Using a coliwasa, we collected a stratified sample from the tank (see Photograph 2)

Using standard semi-quantitative wet chemistry methodologies, we determined that the pH of the septic tank contents was 7.2.
