**Preliminary Assessment
of an
Identified Illegal Drug Laboratory
at:**

**611 South Clarkson Street
and
615 South Clarkson Street
Denver , CO 80209**

September 27, 2013

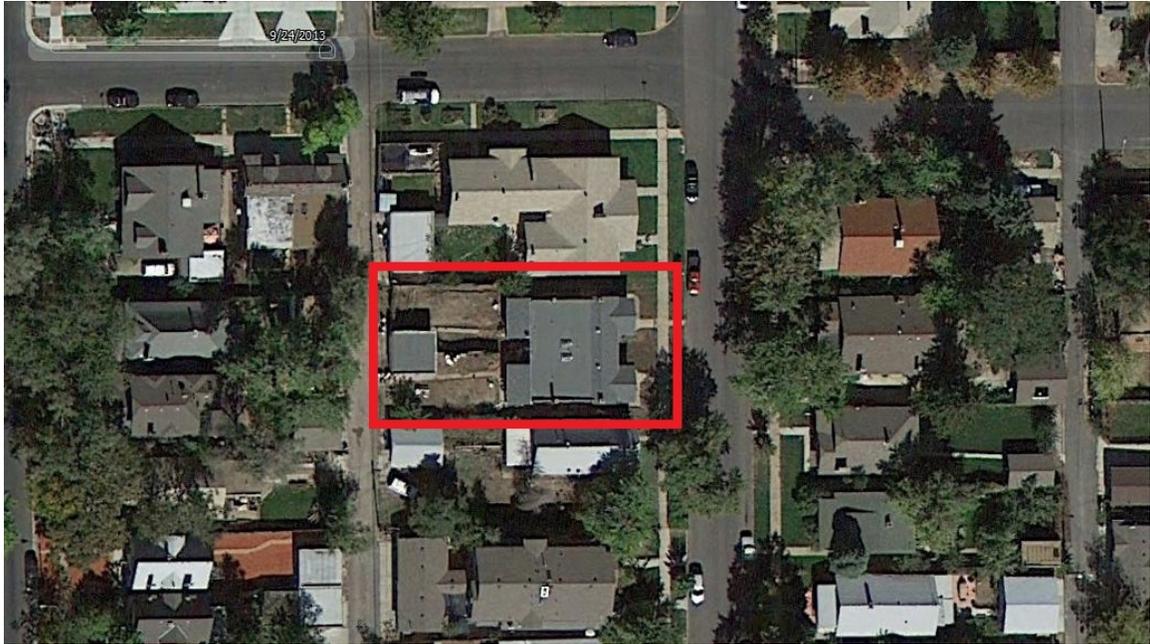
**Photograph 1
General Site Layout⁸**

A general layout of the structure is depicted in the aerial photographs below. The subject property is outlined in red; north is at the top of the photograph.

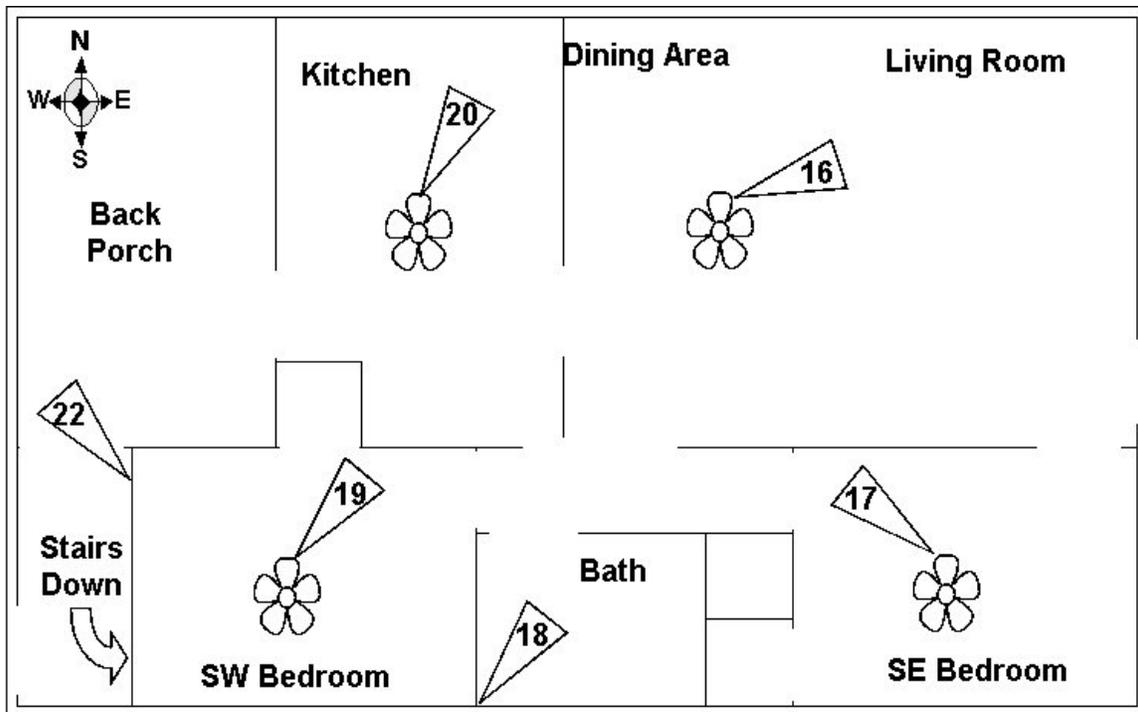
Figure 2
611 Grade Level Samples

In the figures that follow, the sample locations have been presented. The drawings are stylized and not intended to be architectural representations and are not necessarily to scale. In the diagrams, the sample locations are indicated by triangles.
