**Preliminary Assessment  
of an  
Identified Illegal Drug Laboratory  
at:**

**1650 S Deframe Street  
Unit C8  
Lakewood, CO**

**FORENSIC APPLICATIONS CONSULTING TECHNOLOGIES, INC.**

January 12, 2014

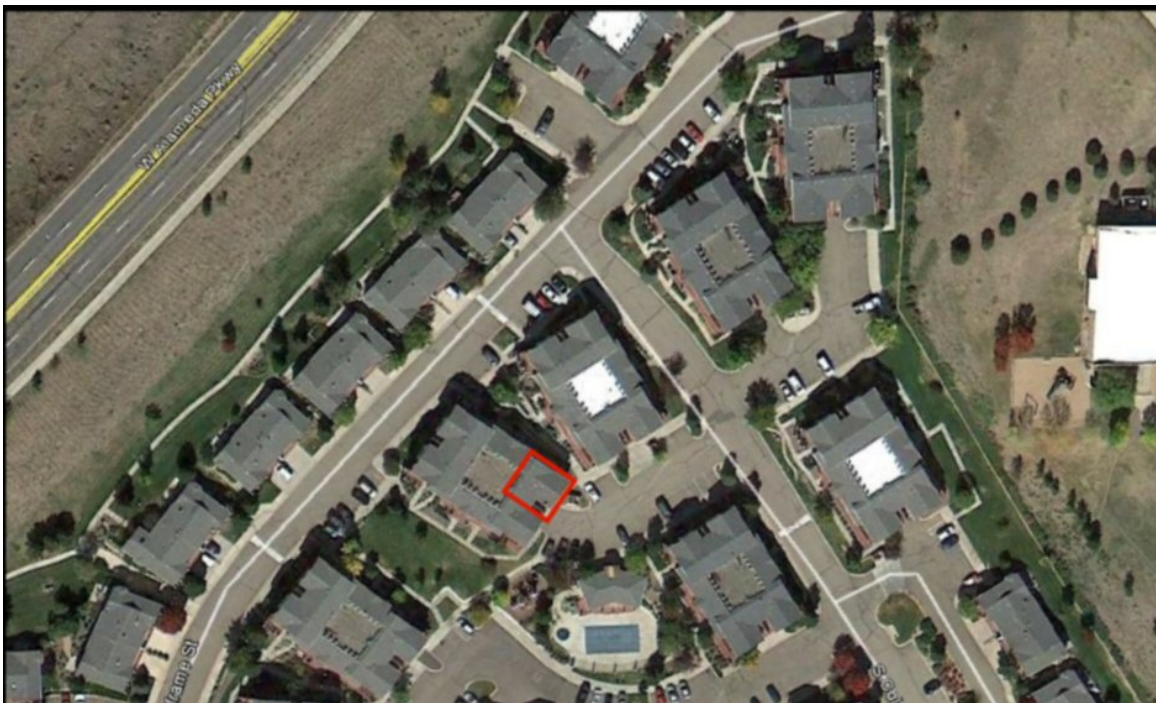
**Photograph 1  
General Site Layout<sup>5</sup>**

A general layout of the residential structure is depicted in the aerial photograph below. The subject property is outlined in red; north is at the top of the photograph.
