**Preliminary Assessment
of an
Identified Illegal Drug Laboratory
at:**

**2268 Golden Gate Grove
Colorado Springs, CO**

Prepared for:
**Silver Inn, LLC
PO Box 23702
Silverthorne, CO 80498**

April 16, 2013

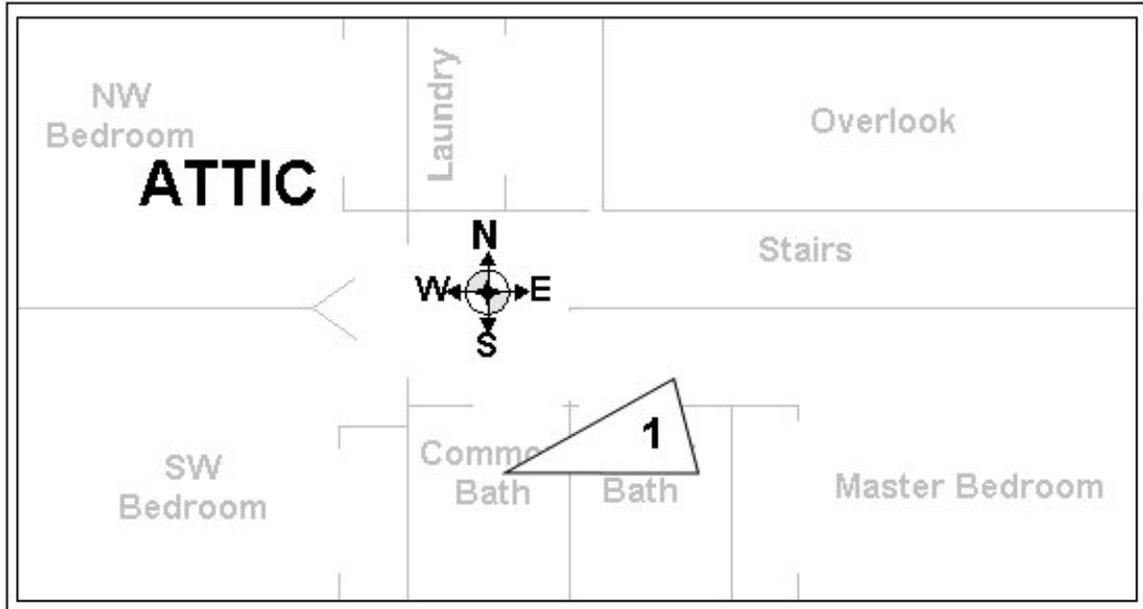
Figure 1
Attic Sample Location

In the figures that follow, the sample locations have been presented. The drawings are stylized and not to scale. In the diagrams, the sample locations are indicated by triangles. Where the identifier has a shaded triangle, the sample was collected during the cursory evaluation.
