**Preliminary Assessment
of an
Identified Illegal Drug Laboratory
at:**

**1299 Vondelpark Drive, Unit C,
Colorado Springs, CO 80907-4089**

Prepared for:
Air Academy FCU
9810 N. Union Blvd.
Colorado Springs, CO 80924

August 10, 2012

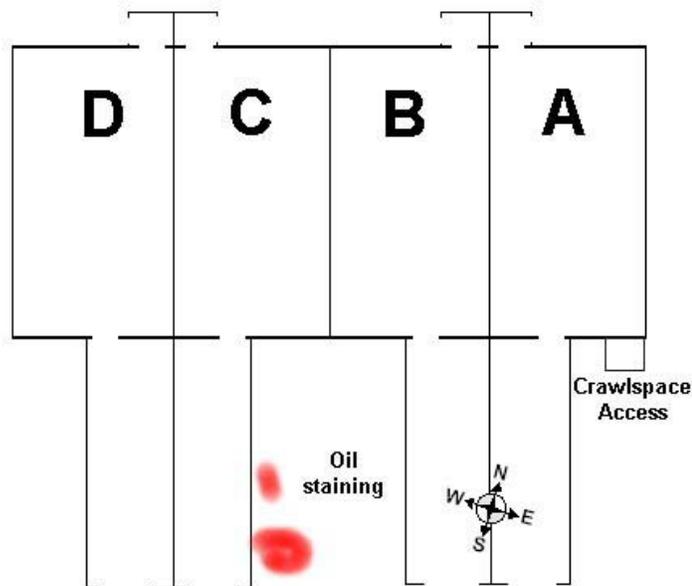
Figure 2
Figure of Exterior Indicators.

Although not truly a functional space *per se*, the exterior grounds were assessed independently. At the time of our investigation, we observed gang related graffiti on the structure. There were visual signs of motor oil being discarded in the back of the residence, however, there were no indicators in the exterior grounds that spoke to illegal disposal (such as stressed vegetation) associated with clandestine drug operations. In general, the grounds would not be conducive to clandestine disposal. The Drawing below indicates the location of the staining in the exterior grounds.

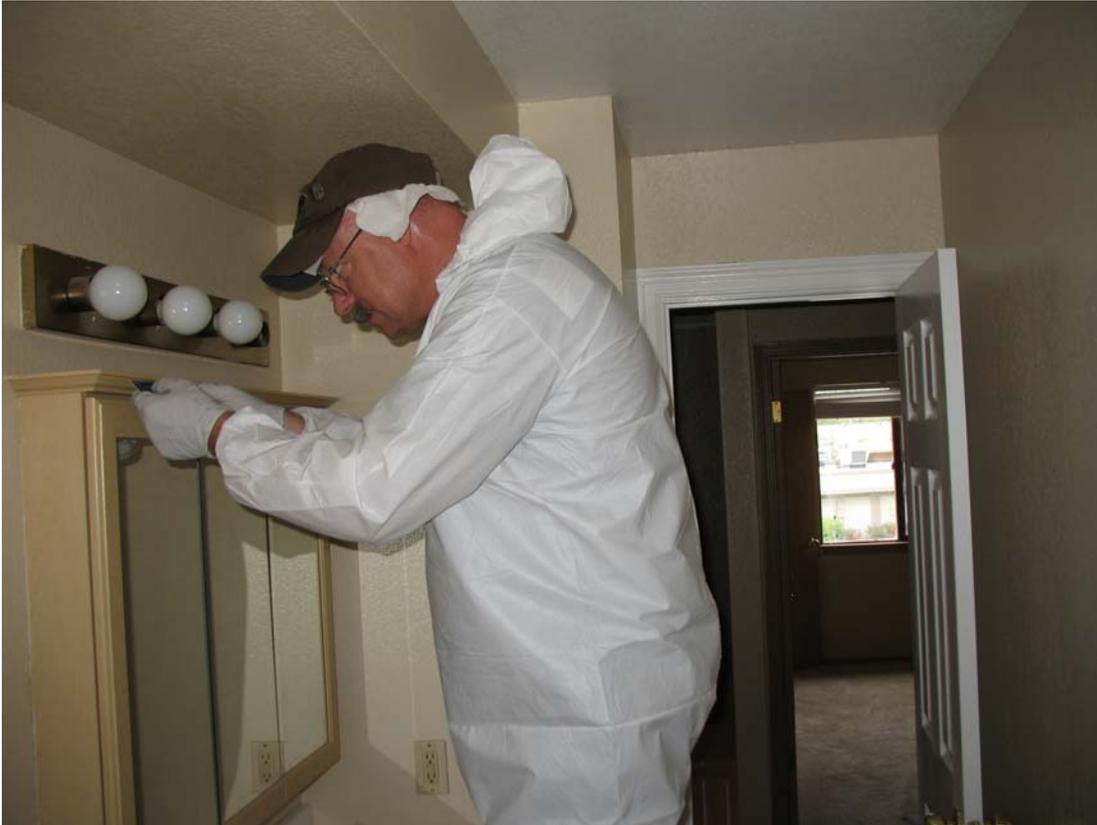
Photograph 1
Sampling Convoluted Topographies

Due to the primary objective of sampling (identified by item number “3” in the above list), the surfaces so selected are frequently convoluted and intricate surfaces. As such, the most appropriate surface is often an item of convoluted topography, and even the use of a template would be impossible. For example, when sampling a medicine chest (see Photograph 1 below), the use of a template would be impossible, and the delineation of the surface area is derived from the physical boundaries of the item.

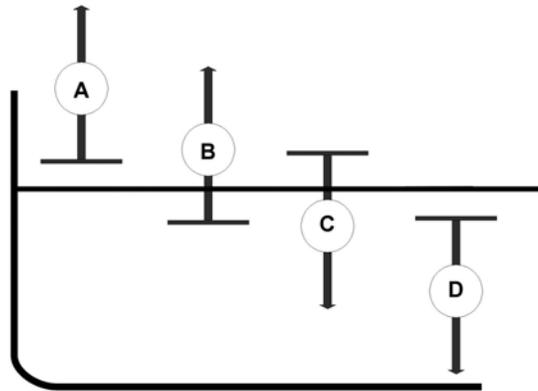
Figure 4
Uncertainty in Reported Values

However, there is an ambiguous zone of reported values, such as (B), where although the reported value is greater than the decision threshold, there is a probability the true value is less than the decision threshold. Similarly, where the reported value is less than the decision threshold, there is a probability the true value is greater than the decision threshold (C).

Standard Industrial Hygiene sampling protocols require that the Industrial Hygienist (IH) consider this degree of uncertainty, known as the total coefficient of variation (Cv_T), for each method. The Cv_T includes the uncertainty associated with both the sampling and analytical processes. For many methods, such as this analysis method, the degree of analytical uncertainty is known and published, and is generally small. However, for field methamphetamine sampling, the statistical uncertainty is generally very large. When we analyze field data from fully characterized properties, we see that the variation of concentrations from the building as a whole usually exhibits a lognormal distribution. As such, geometric standard deviations can be as large as 3.0. This distribution is similar to that reported elsewhere.^{17, 18}

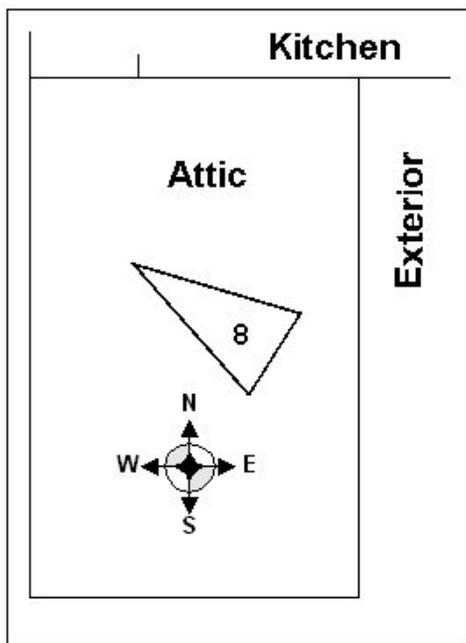
Figure 5
Attic Sample Location

The property appears to have two attics, one for the garage and one above the second floor. This space did not contain any subjective indicators. The space was challenged with a discrete sample (Sample VM080112-08) which indicated a methamphetamine concentration of approximately 3µg/100cm².

In the figures that follow, the sample locations have been presented. The drawings are stylized and not intended to be architectural representations and are not to scale. In the diagrams, the sample locations are indicated by triangles. Gray-fill locations indicate probable storage/cooking areas.

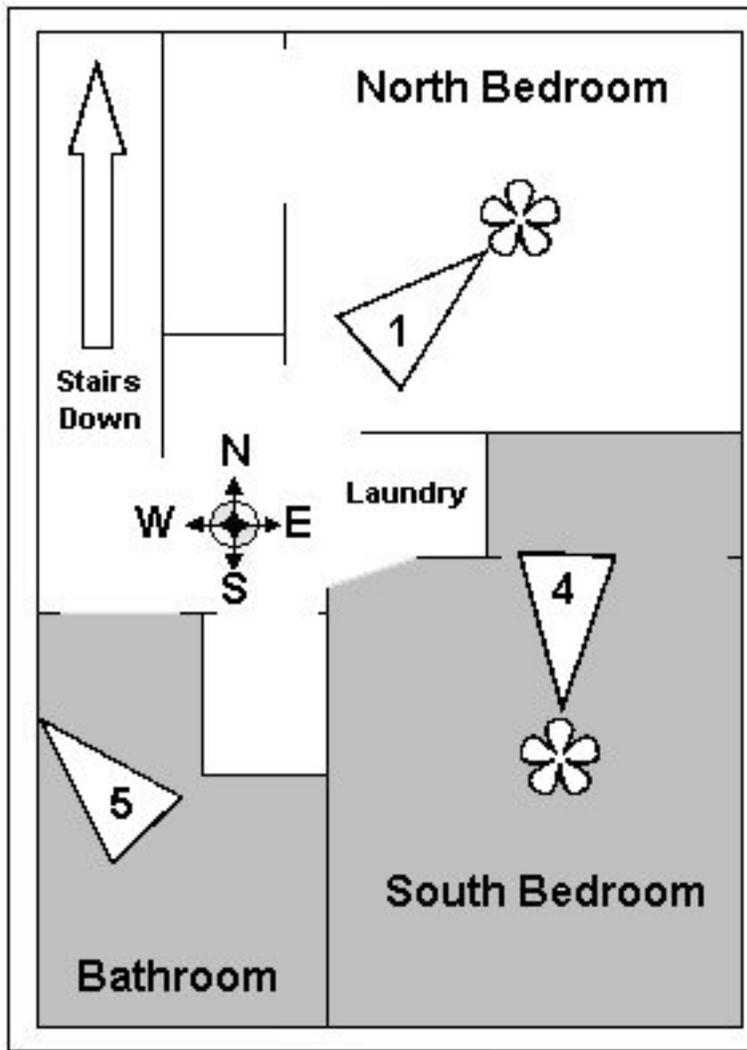
Figure 6
Upstairs Sample Locations

concentration of approximately 24 $\mu\text{g}/100\text{cm}^2$. Based on the totality of circumstances, we believe this space was the primary location of a methamphetamine production operation. We believe the Upstairs South Bedroom was the secondary location of production.

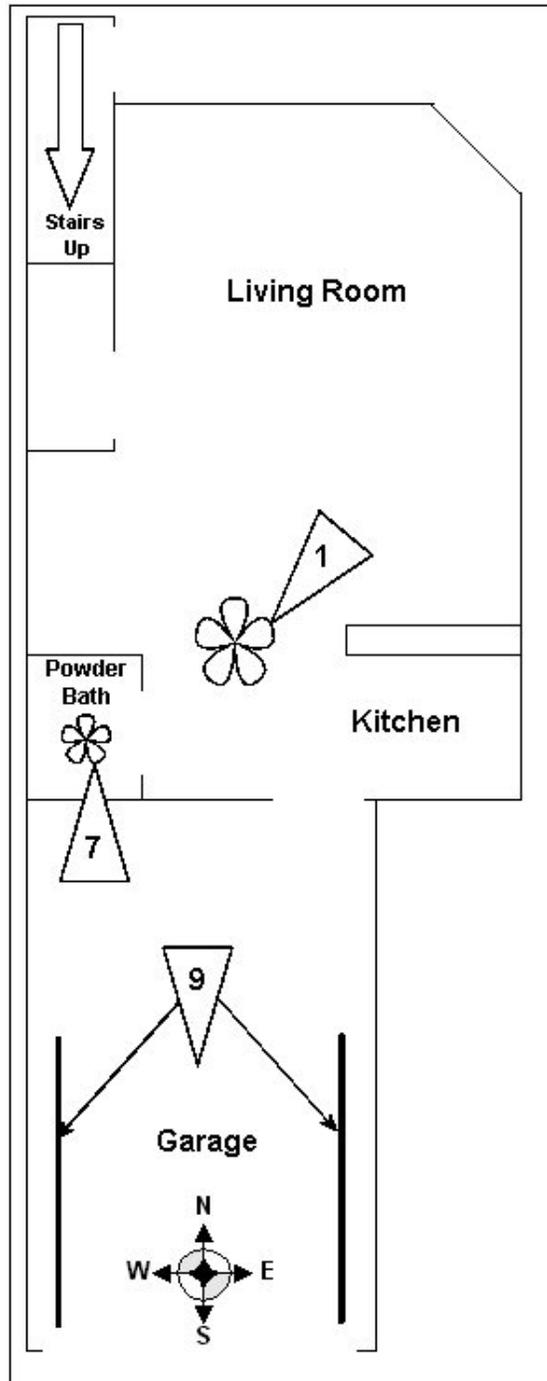
**Figure 7
Ground Floor Sample Locations**

This space is the garage as that term is commonly understood. This space had several visual indicators of illegal drug use including hidden syringes. We attempted to clear this functional space with Sample VM080112-09, which indicated a methamphetamine concentration of 11 µg/100cm².
