**Preliminary Assessment
of an
Identified Illegal Drug Laboratory
at:**

**646 Vrain Street
Denver, Co 80204-2951**

**Unlocking Equity, LLC
7350 E Progress Place, Suite 100
Greenwood Village, CO 80111-2130**

January 17, 2015

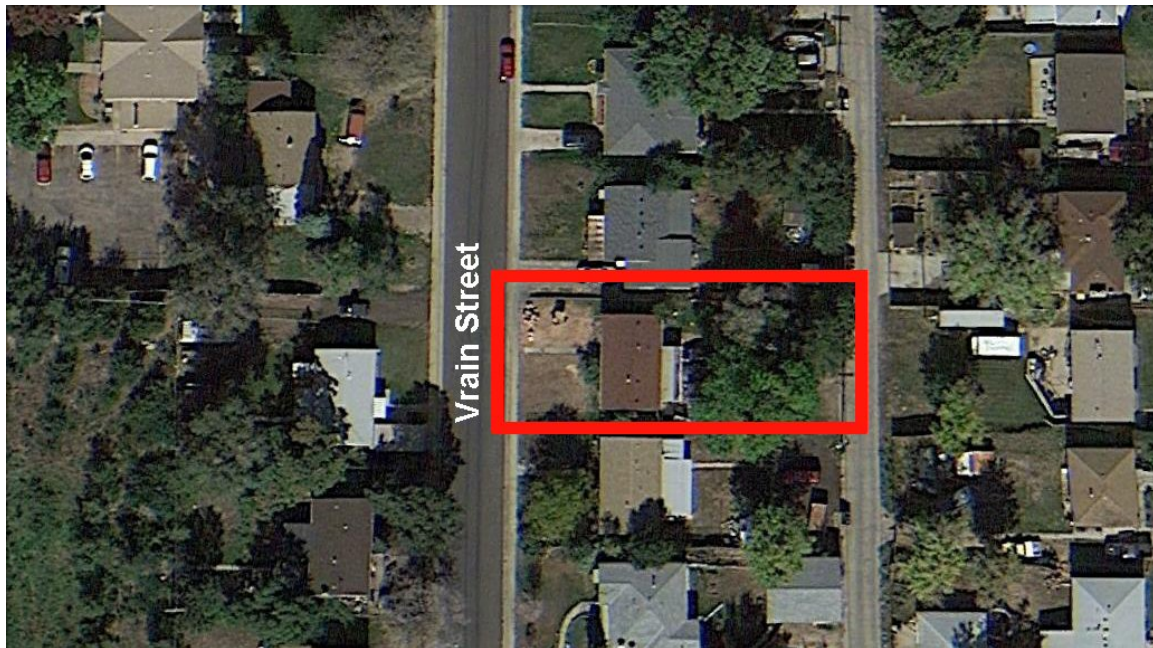
Figure *
General Site Layout²

A general aerial layout of the residential setting is depicted in the photograph below; the subject property, is approximated by the red outline.
