FORENSIC APPLICATIONS CONSULTING TECHNOLOGIES, INC.

August 10, 2015

RE: 769 Cleveland Circle, Lafayette, CO 80026

RE: 769 Cleveland Circle Lafayette, CO 80027 Methamphetamine (Meth) Affected Property Post-Decontamination Report

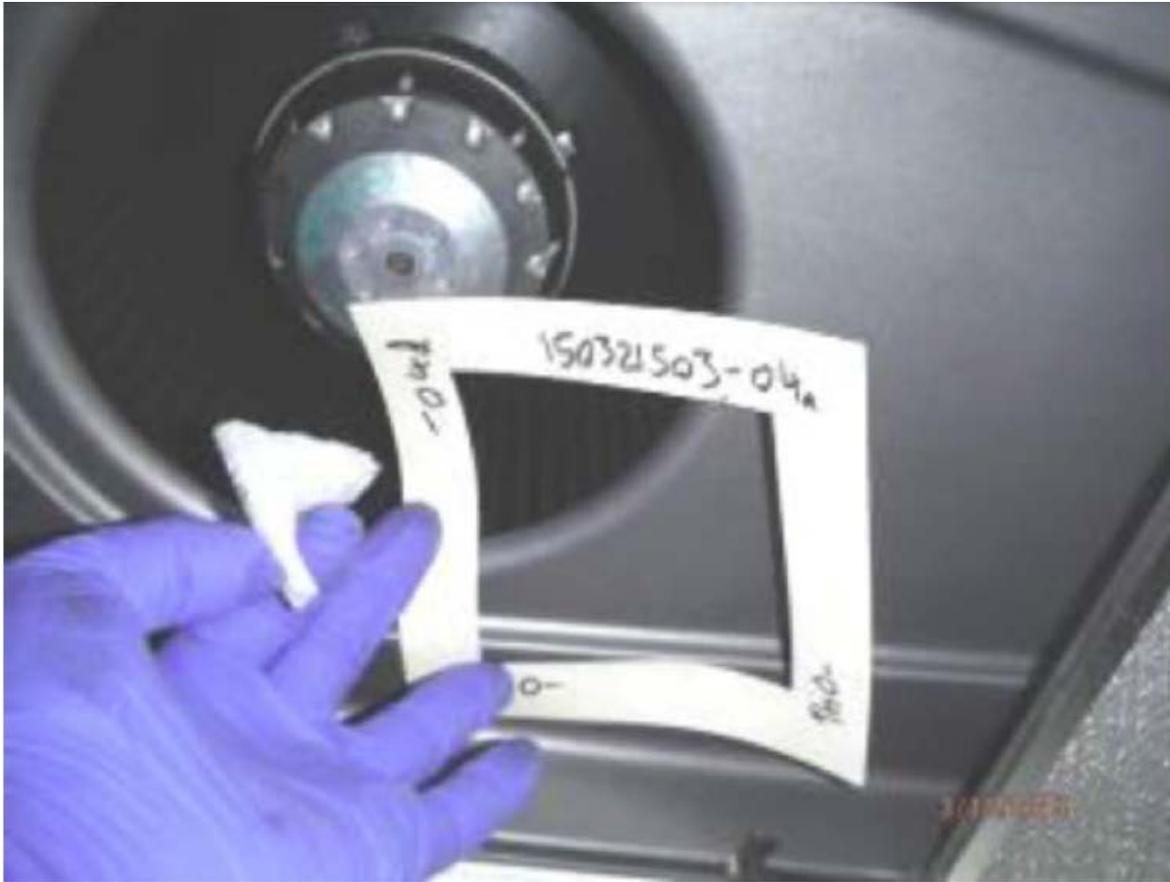
In the first photograph below, the consultant holds the template over an area that is approximately 50% empty space, and collected a sample from an area that is actually only about 60cm² (it is also interesting to note that the photograph documents the fact the consultant was violating regulation§6.2.2 by re-using his templates, and selecting areas from which it is impossible to comply with the sampling requirements found in §6.2.7.1 and required by § 6.2.10).

Several other such photographs are discussed in our review of that work wherein we identified no fewer than 55 regulatory violations.¹

In any event, contrary to common belief, the use of templates is not required, and as demonstrated in the above photograph, such inappropriate use results in inappropriate (and unlawful) sample collection. The public records don’t indicate if Mr. Richen issued a similar rejection letter to the owner of 771 Cleveland Circle, Lafayette, CO 80026 regarding the illegal assessment at that property from which this photograph was taken. If such a letter has not been

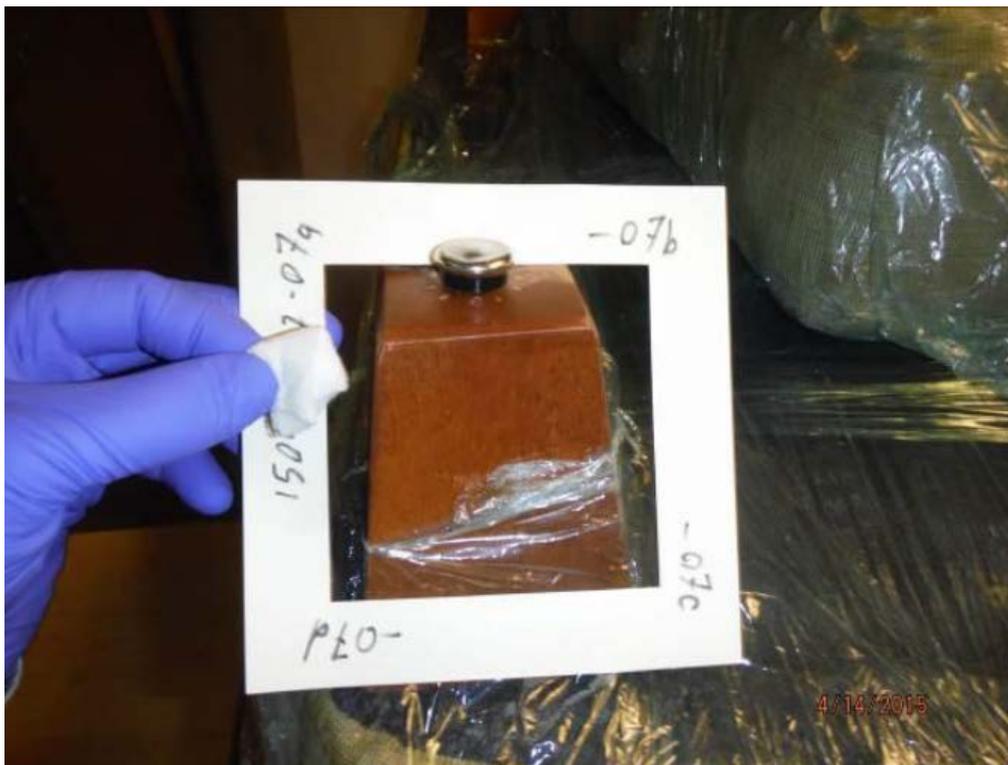
Below is another example from the same contractor, but for a different property in Boulder County.² This photograph similarly demonstrates three different violations 1) failure to collect 100 square centimeters, 2) re-use of templates, and 3) failure to collect samples pursuant to §6.2.10 (which, Mr. Richen has stated elsewhere, invalidates the entire sample). Again, we presume that Mr. Richen similarly issued a rejection letter to Ms. Julie Swick, the owner of the property to inform her that the work performed at her property contained multiple regulatory violations, and was thus rejected by Mr. Richen.
