FORENSIC APPLICATIONS CONSULTING TECHNOLOGIES, INC.

RE: 131 South Benton Street, Denver, Colorado

We have reviewed the March 5, 2008 letter by Quest Environmental wherein Quest describes additional sampling at 131 South Benton Street, Denver, Colorado. The following discussion is a critical review of the Quest Report.

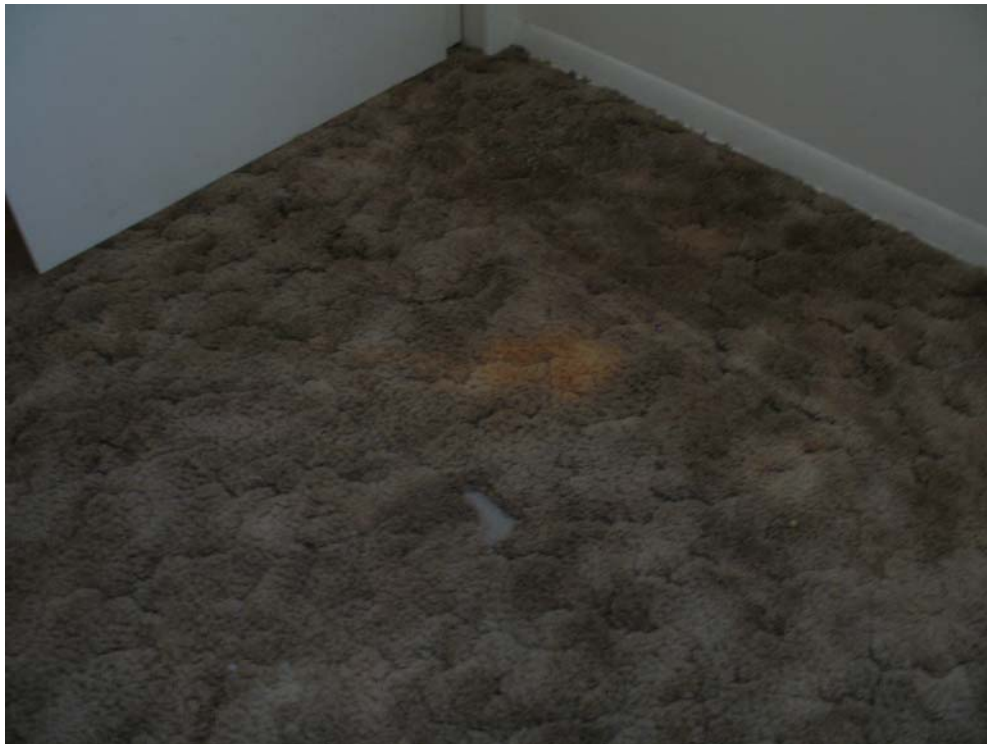
Photograph 1
Indicator Staining on Carpet

It is similarly not known why Quest mentions red phosphorous specifically, when Quest has already stated that it had no knowledge of the manufacturing process. However, during our cursory evaluation of the subject property, FACTs collected approximately 50 photographs. Several of the photos clearly demonstrate chemical staining, chemical burns, thermal burns and **profound** staining consistent with the red phosphorous method, all consistent with methlab activity.

For example in the photo below, taken by FACTs in one of the bedrooms, we see the staining on the carpet.

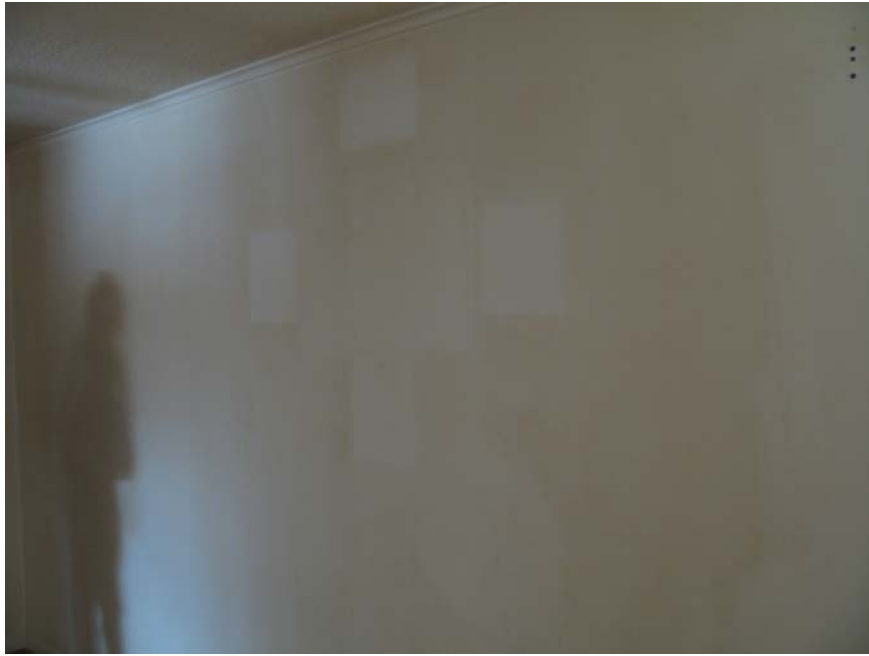
Photograph 2
Indicator Staining on Living Room Wall

Similarly in the next photograph (also taken by FACTs during our cursory sampling visit), we see the staining on the living room wall; the staining is consistent with the red phosphorous method.

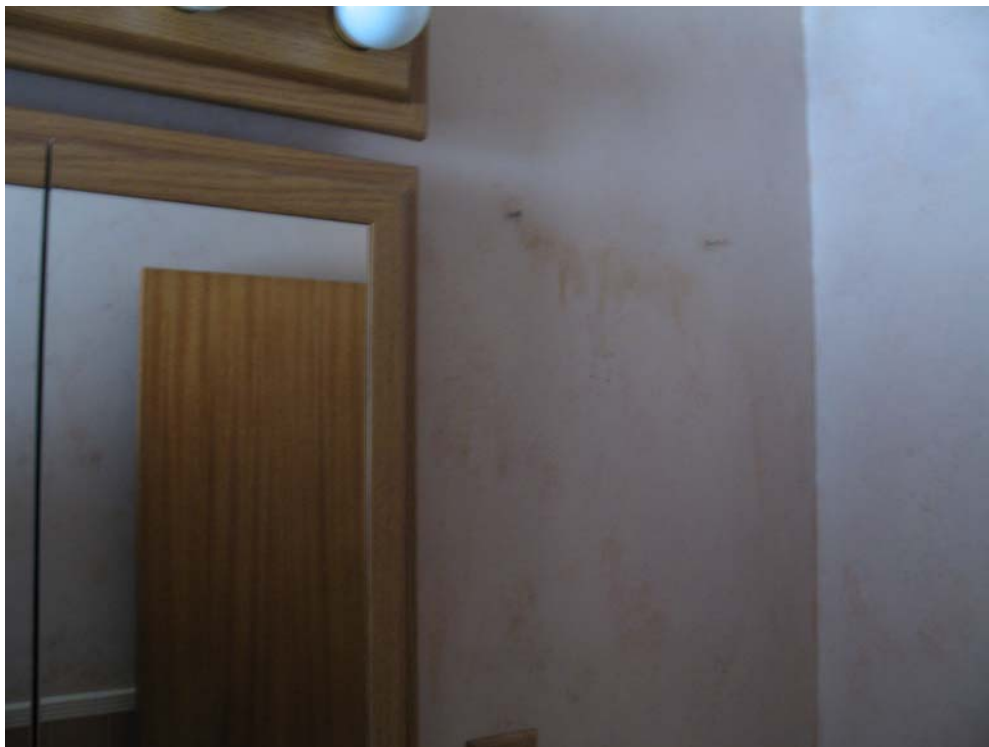
Photograph 2A
Indicator Staining on Bedroom Wall

Similarly, other yellow/red staining occurred throughout the property such as the staining on the southeast bedroom wall depicted in the FACTs photograph below.

Furthermore, Quest has demonstrated that they lack any legitimate training in methlab issues in that they apparently entirely fail to recognize that the red staining most often associated with the “red phosphorous” method is **NOT** due to red phosphorous.

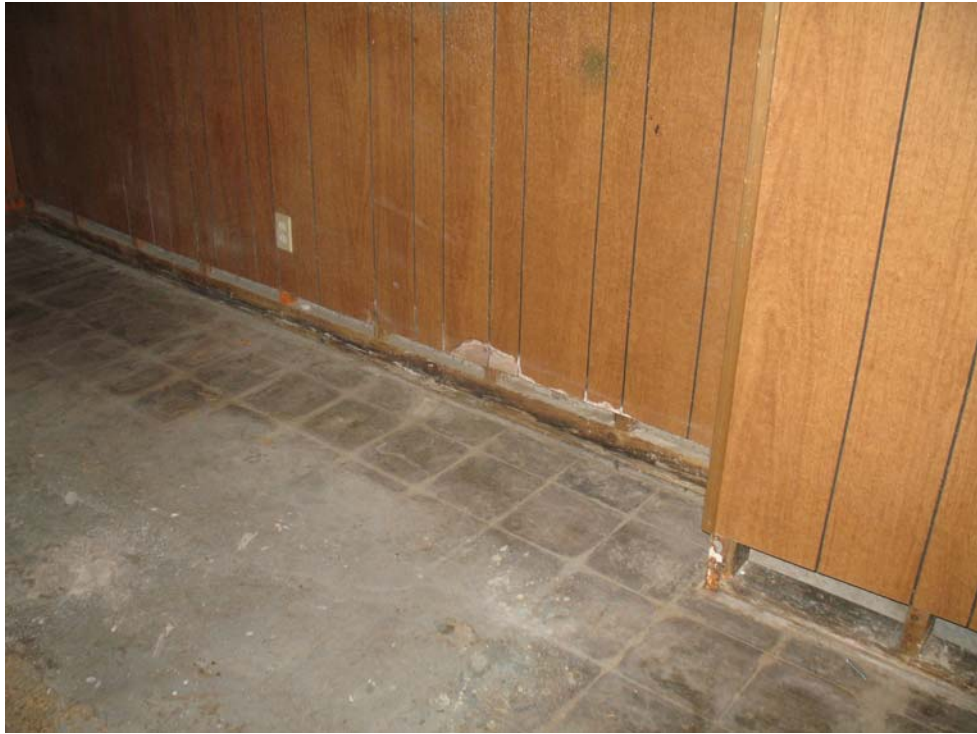
Photograph 3
Photograph of Basement Water Loss Indicators

- Basement main room floor
 - A trained consultant would have noticed that a significant water loss had occurred in the basement, in the area where the sample had been collected, wherein extensive flooding had taken place (See the flood cuts and water staining, for example, in the photograph below, taken by FACTs, during our cursory visit).

The flood cuts in the wall (bottom right of photograph) indicate a significant loss. The concrete floor in the photograph exhibits the location of floor tiles that were lifted or removed as a result of the flooding. Therefore, based on our cursory visit alone, FACTs can conclude that the floor of the basement would constitute an area that would be expected to have one of the **LOWEST** possible levels of methamphetamine in the house; the meth having been washed away by the flood.
